FINAL REPORT

Intermodal Transportation Infrastructure Interactions: Utilizing Acoustic
Emission and other Non-Destructive Evaluation Technologies

September 2014

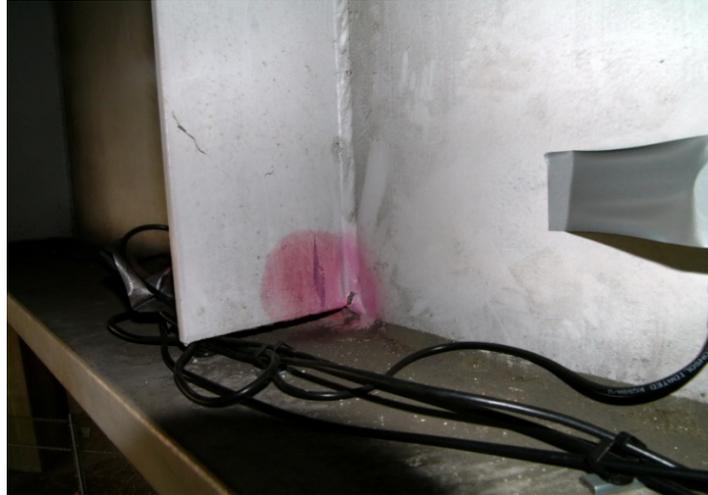
Girder 9 of this bridge had a visually identified defect (crack) at the stiffener-to-girder weld (Fig. 3). Girder 8 did not have any visually identified deficiencies.

Figure 3: Existing crack in the stiffener-to-girder connection weld on girder 9.

VDOT is currently paying more attention to this suspected location. Dye penetrant tests were carried out to check for the presence of hairline cracks. It is recommended to carry out long-term AE monitoring using the entire length of the girder 9 to determine further levels of AE activity related to growth of the existing known defects as well as to determine other possible defects in this girder that might have contributed to the higher level of AE activity in this structure. AE monitoring should be considered as a regular measure for evaluation of highway bridge health and safety and should be conducted on a larger number of bridges, with the structures that exhibit more AE activity being afforded inspection priority as compared to other structures.

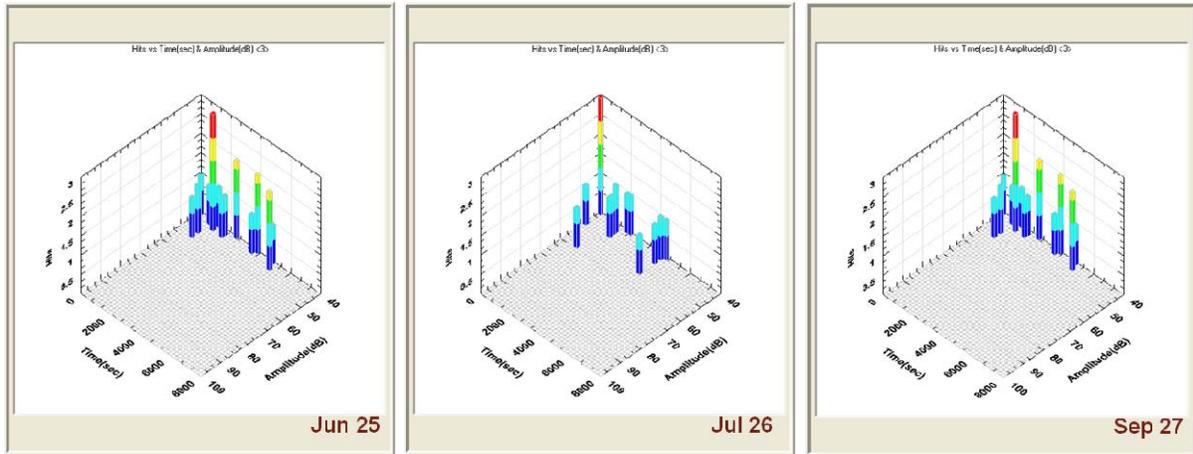
Figure 8: AE activity in girder 8 (single AE sensor).

The amplitude and AE activity in girder 8 appear to be low, which indicates there are probably no active cracks exist in this beam. On the other hand, the AE activity found in girder 9 were much stronger and the amplitude and scale of the AE activity appear to be increasing during the successive periods of measurements. Therefore, there is a strong evidence to suspect that an active crack or other defect exists in this beam and results in such strong AE. These measurements were taken during the high traffic conditions on work days around 11:00 am for periods of about 1 hour 30 min. Beam 9 had 2 AE sensors installed at this point (sensors 4 and 5 in Fig. 5 above).

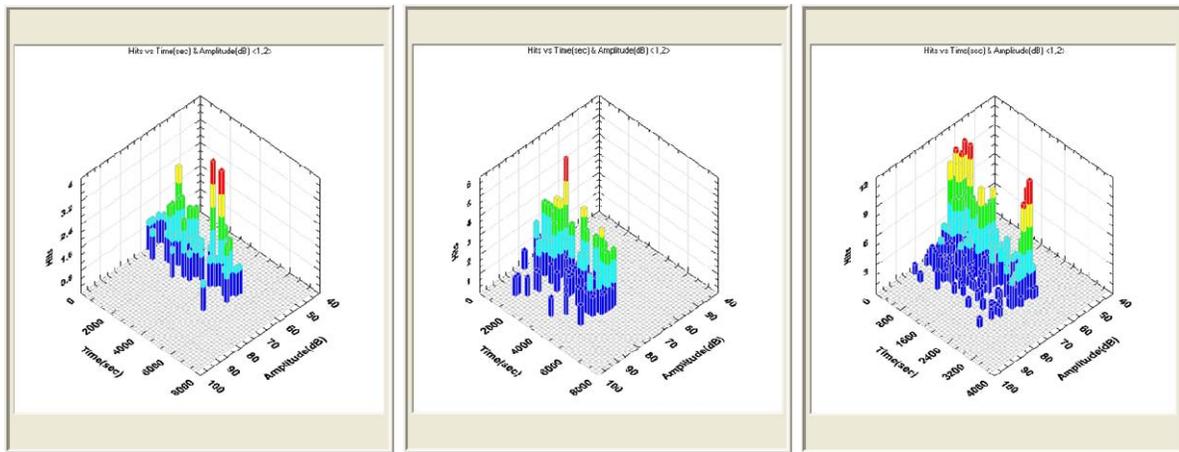
Figure 9: AE activity in girder 9 (two AE sensors).

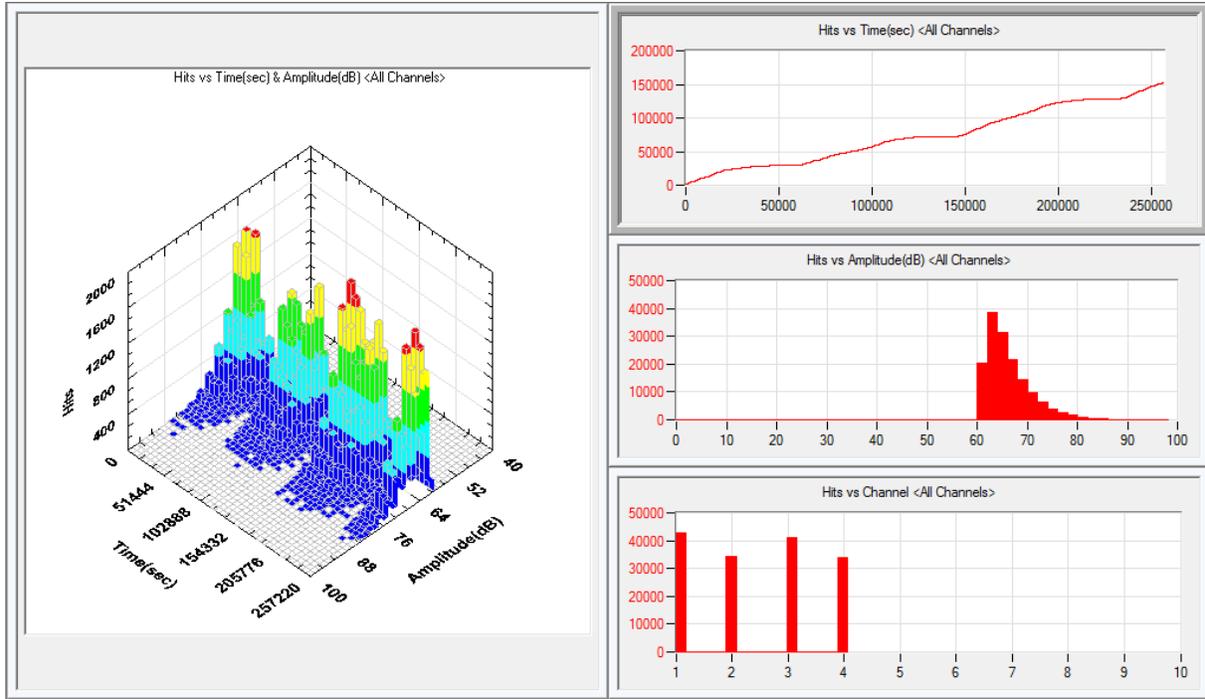
Figure 10: Long-term measurement of AE activity on girder 9 (4 AE sensors).

Two additional transducers of the same type (R15I-LP-AST 150 kHz) were then installed on girder 9. Fig. 10 shows the result of the long-term measurement conducted over a period of almost 3 full days (2 days 23 hours 27 min) covering high and low traffic conditions and it clearly indicates the presence of strong AE activity in this beam.

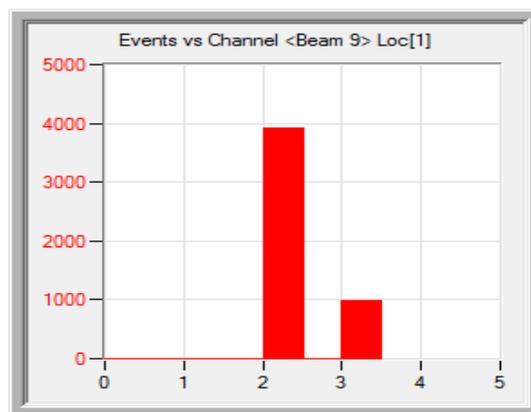
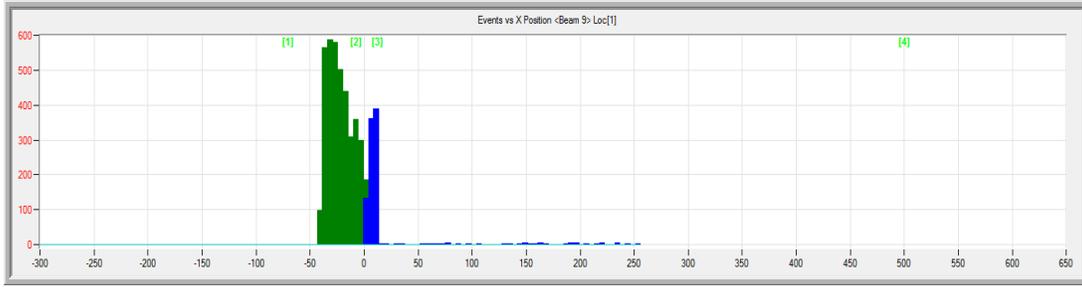
Figure 11: Linear location analysis of the AE activity on girder 9 using data from 4 transducers – Events vs. Channels (top) and Events vs. X-Position (bottom). Events were determined to be attributed to sensors 4 and 5.

The linear location analysis presented in Fig. 11 shows that the majority of the AE activity originated in the regions between sensors 2 and 4 and sensors 4 and 5. The existing defect on this girder (visually identified crack) is located between sensors 4 and 5. Subsequent two-dimensional location analysis of the data (Fig. 12 below) also confirmed intensive AE activity source at this location.

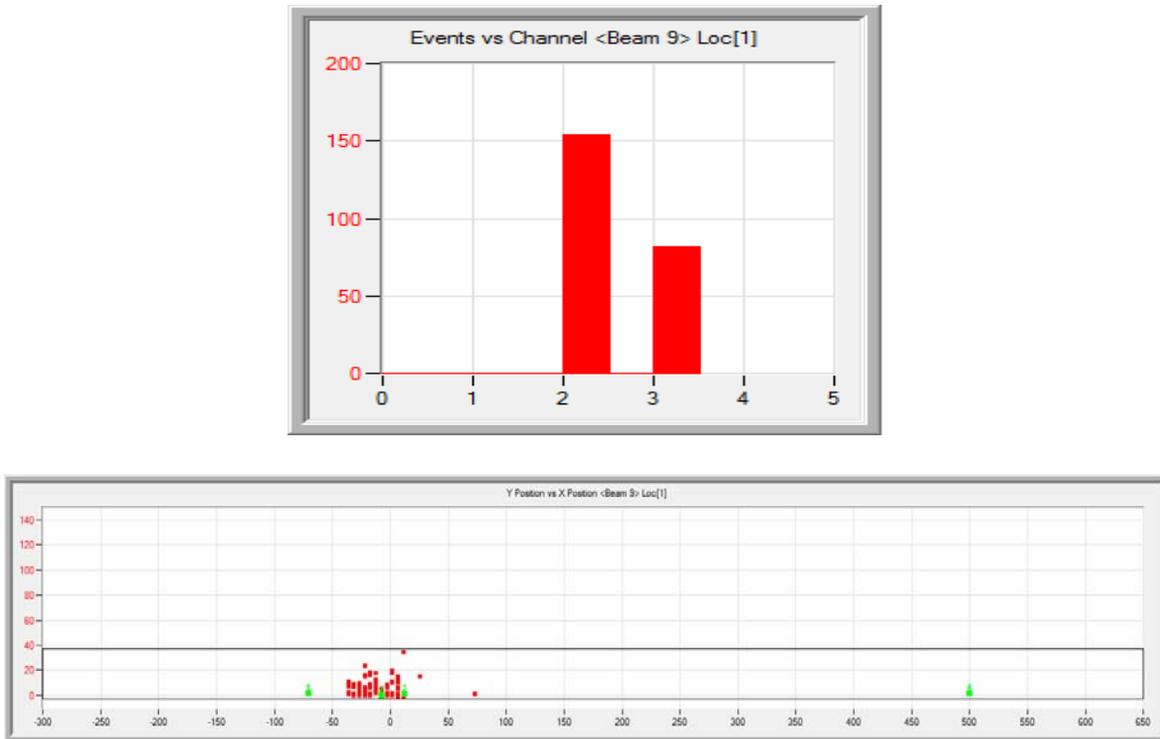
Figure 12: Two-dimensional location analysis of the AE activity on girder 9 using data from 4 transducers – Events vs. Channels (top) and Y-Position vs. X-Position (bottom). Events were confirmed to be attributed to sensors 4 and 5.

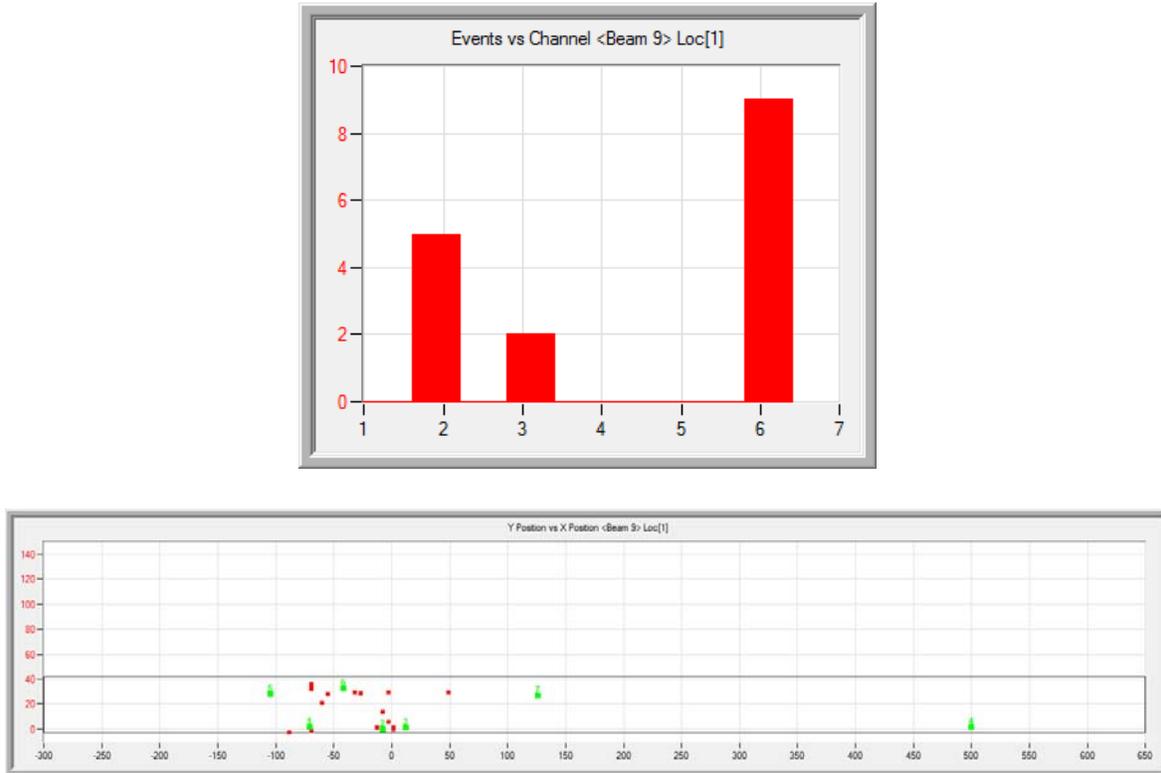
The results of the two-dimensional location analysis using all 7 AE sensors are presented in Fig. 13. This data was obtained during the work day high traffic condition around 11:00 am for the duration of 1 hour 20 min. This short-term data did not produce as many AE source locations as previously, but nevertheless it confirmed strong AE hits in the area between sensors 2 and 5.

Figure 13: Two-dimensional location analysis of the AE activity on girder 9 using data from 7 transducers – Events vs. Channels (top) and Y-Position vs. X-Position (bottom). This analysis attributed events to sensors 3, 4, and 5.
