FINAL REPORT

Intermodal Transportation Infrastructure Interactions: Utilizing Acoustic
Emission and other Non-Destructive Evaluation Technologies

September 2014

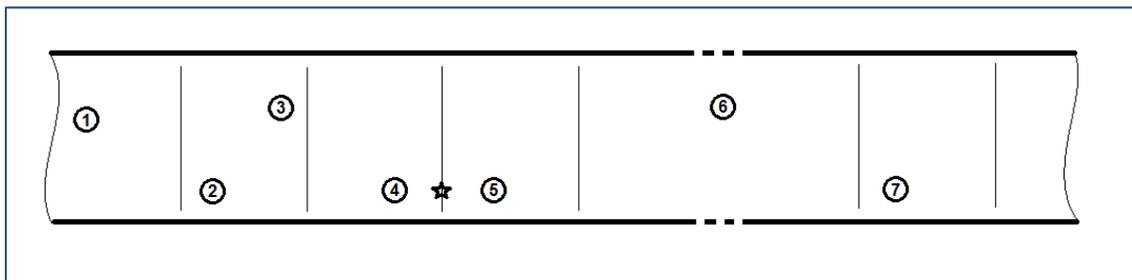
Sensor	AE Channel	Direction (from crack)	Distance, in (from crack)	Height, in (from bottom of girder)
1	5	left	105	31
2	1	left	71	approx. 5
3	6	left	42	36
4	2	left	8	approx. 5
5	3	right	12	approx. 5
6	7	right	126	30
7	4	right	495	approx. 5

Figure 5: Diagram of sensors locations on girder 9 (not to scale). The crack location is marked with star.
